# Intel<sup>®</sup> Itanium<sup>®</sup> 2 Processor

## Specification Update

Document Number: 251141-033

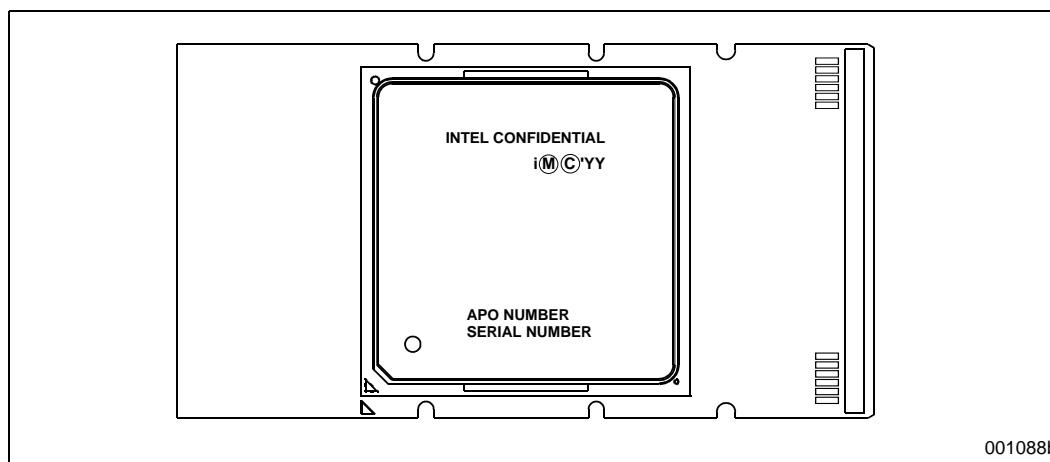
Figure 1-1. Processor Top-Side Marking on IHS

Figure 1-1 shows an example of the laser marking on the IHS. The processor top-side mark provides the following information:

- INTEL Brand/ INTEL Product
- Legal Mark
- Assembly Process Order (APO) Number
- Serial Number

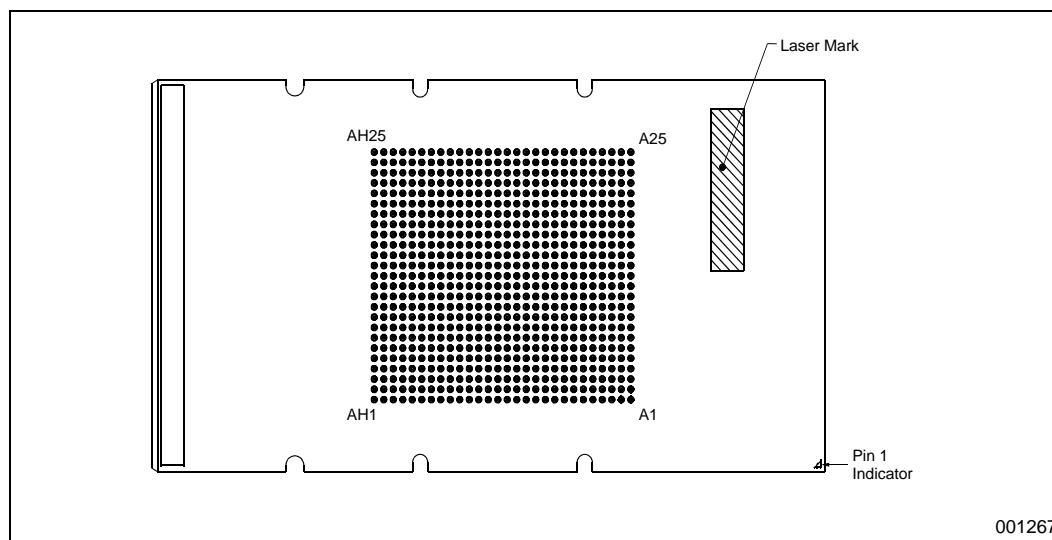
Figure 1-2. Processor Bottom-Side Marking Placement on Interposer

The processor bottom-side mark for the product is a laser marking on the pin side of the interposer. Figure 1-2 shows the placement of the laser marking on the pin side of interposer. The processor bottom-side mark provides the following information:

- Product ID
- Finish Process Order (FPO) Number
- Serial Number
- S-Spec
- Country of Origin
- 2D Matrix Mark included on Itanium 2 processor (up to 6 MB L3 cache) only. Not included on Itanium 2 processor (up to 3 MB L3 cache).
